Safety Bulletin 194

Excavator emergency access & egress systems

Version 1 – Published May 2021

OBSERVATIONS FROM TESTS ON SPECIFIC BRANDS AND MODELS

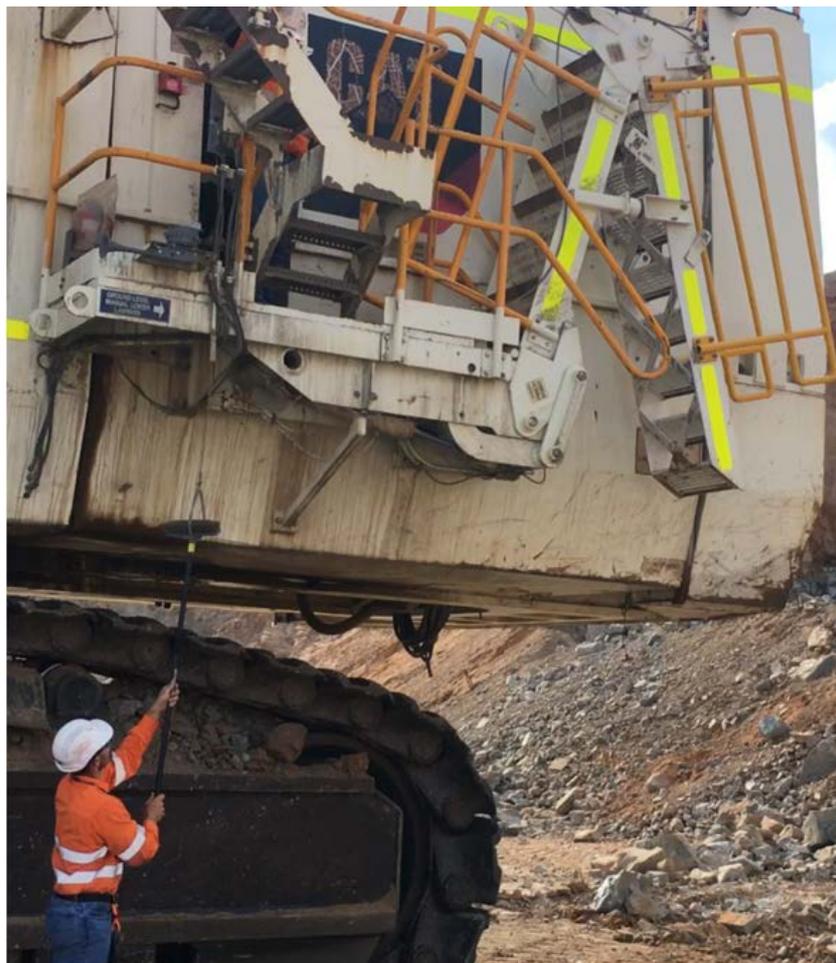
- The cable end was too high to access from ground level. (See Figure 1) We were informed that on both the left and right of the excavator, a rod with a hook was stored within the track frame. This could be used to reach the cable.
- On the side nearest to the cable, the bracket holding the rod had broken off, resulting in the loss of the rod. (See Figure 2). On the opposite side, the brackets were still in position, but there was no rod.
- In case of an emergency where the operator needs to be assisted from ground level, rescuers will struggle to access the machine in a timely fashion.

Figure 1 - Pull wire too high to reach
